Figure 1: Gays River Location Map

STRATIGRAPHIC UNITS, GAYS RIVER MINE

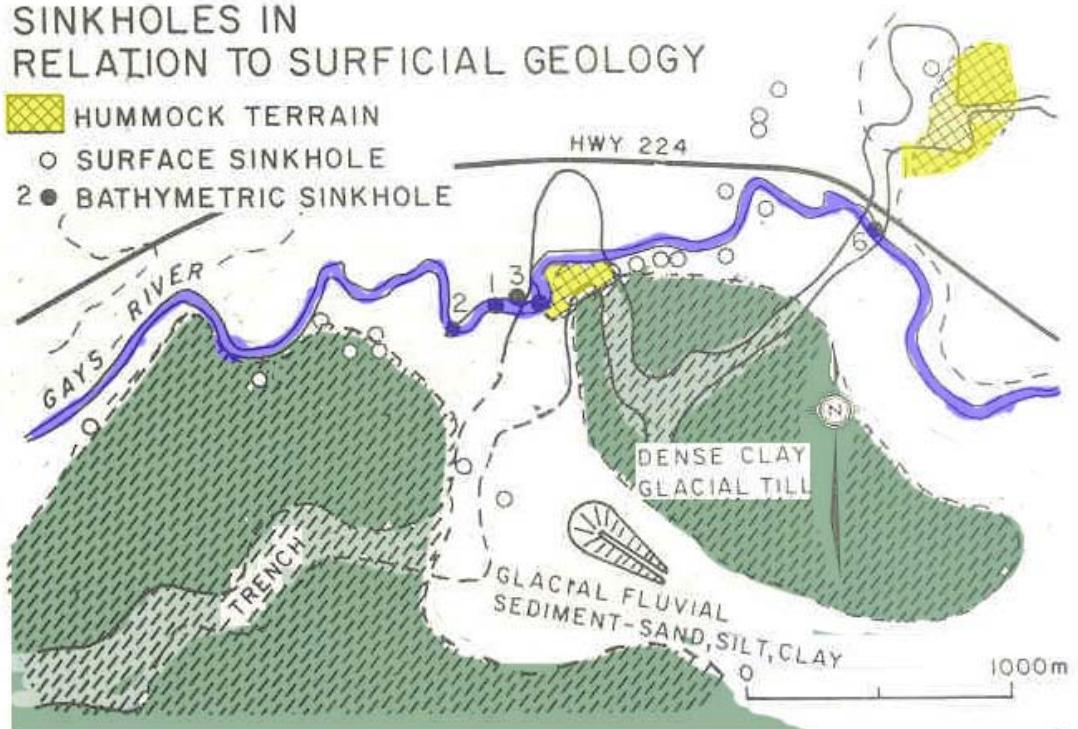
Figure 2: Sinkholes in Relation to Surficial Geology

- HUMMOCK TERRAIN
- SURFACE SINKHOLE
- BATHYMETRIC SINKHOLE

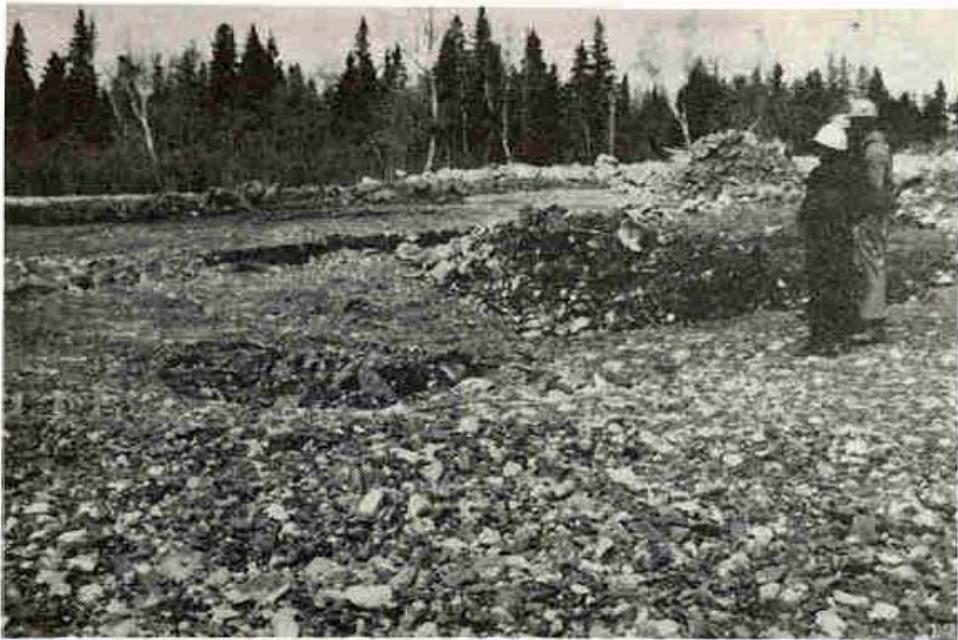
Figure 7: Photo of Sinkhole in Glacial Fluvial Sands Over the 119 Area

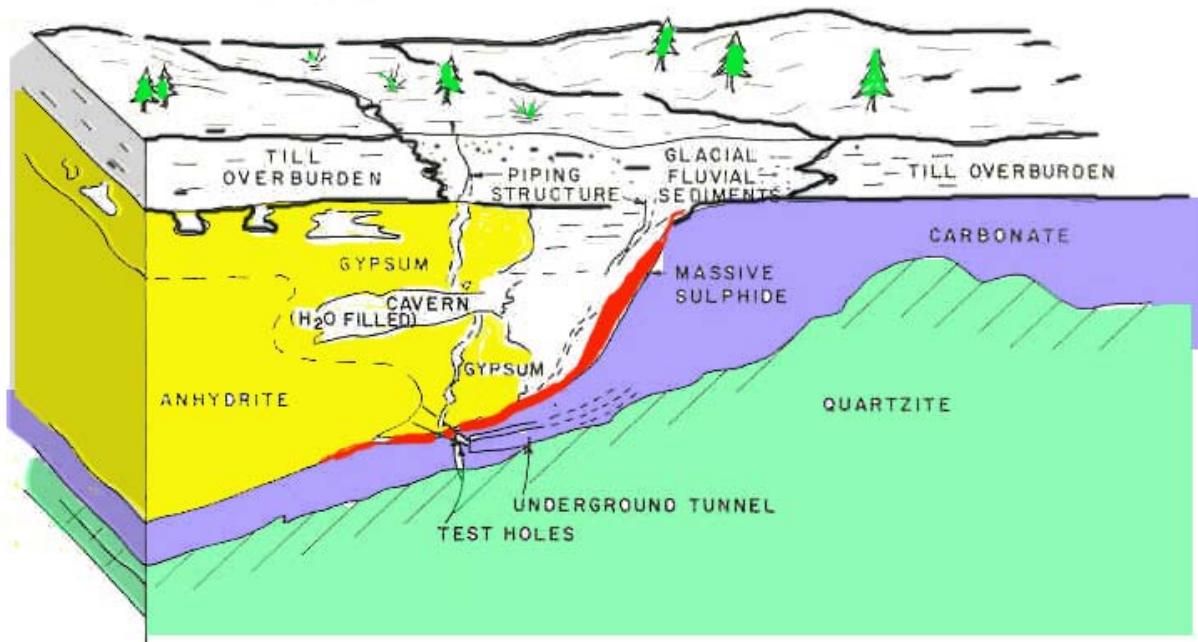
Figure 8 (a): The underground heading is advancing in ore, testholing along the way. The testholes miss the piping structure.

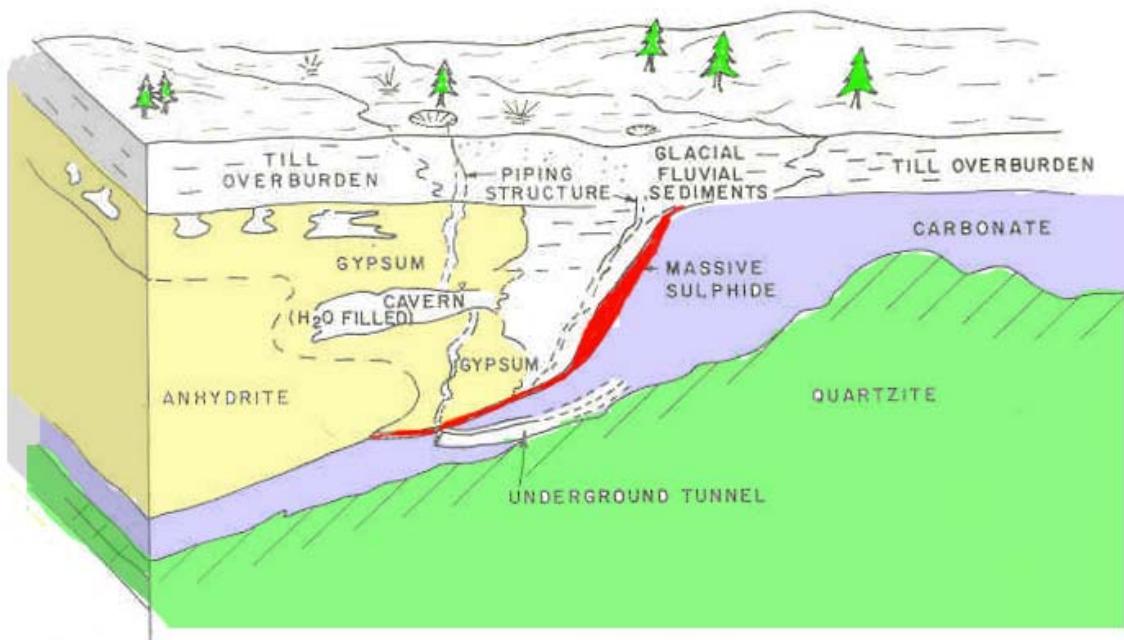
Figure 8 (b): The water-bearing "pipe" is exposed when the round is blasted. The heading floods with water, sand and mud. Sinkholes form on the surface.

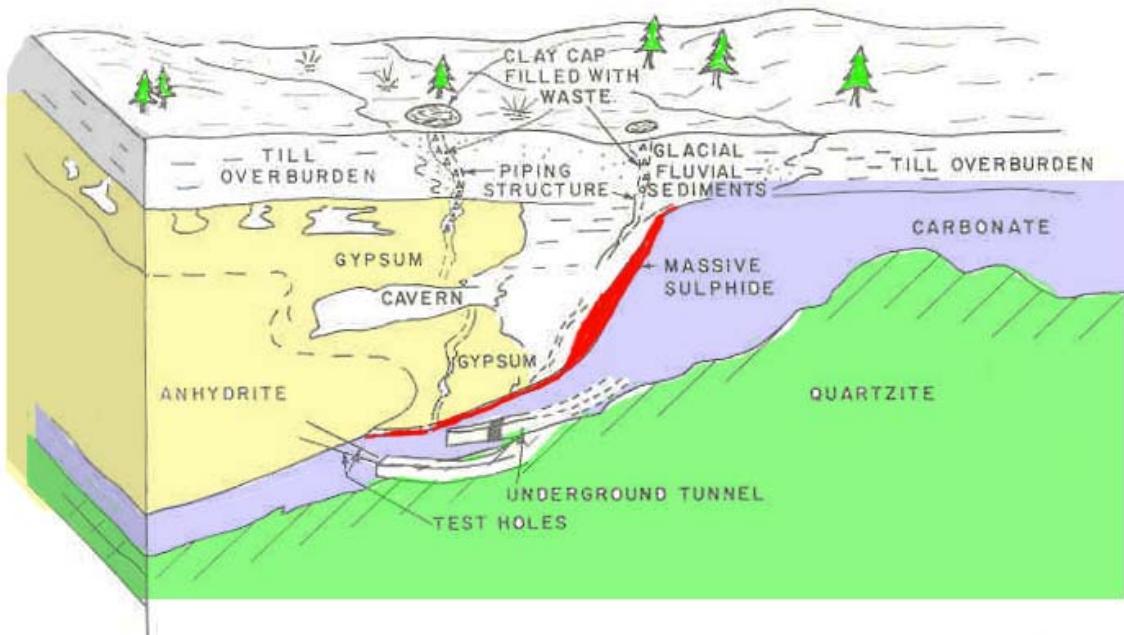
Figure 8 (c): The drift is pumped out and a reinforced concrete bulkhead is built. The heading must go through waste to bypass the water.
